# ENVIRONMENTAL IMPACT ASSESSMENT

Proposed Highway 2000 North South Link -  
Caymanas to Linstead

*Date:*                      **August 2012**

*Prepared by:*          **CL ENVIRONMENTAL CO. LTD.**

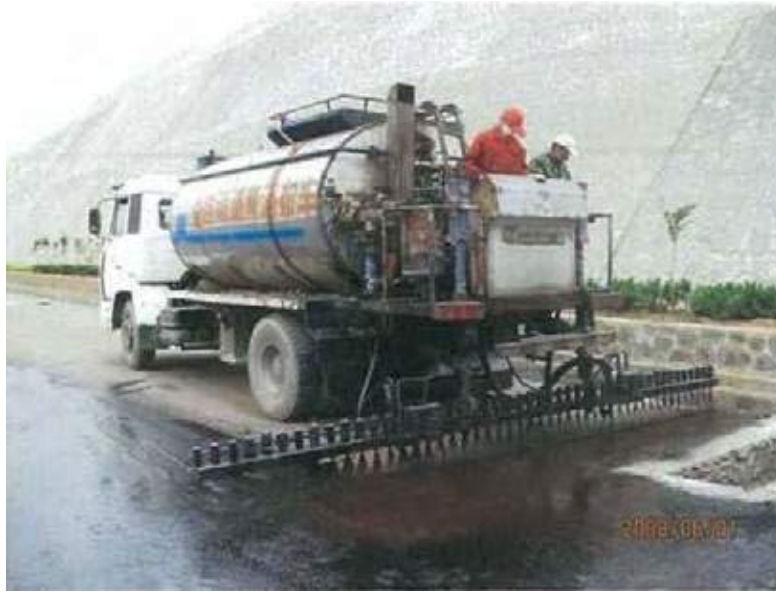
Provide a layer of prime coat or slurry seal on base course and place a layer of tack coat between surface courses (Plate 2.1).

*Plate 2.1 - Asphalt Pavement Construction (Spraying) (source CHEC)*

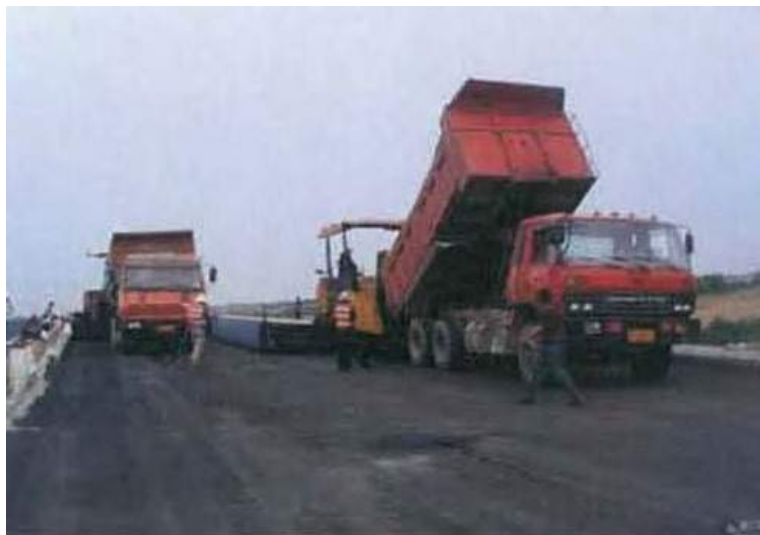
Asphalt concrete shall be transported by dump truck. In order to ensure consecutive spreading work, the dumping truck on site shall not be less than three during laying asphalt concrete (Plate 2.2).

*Plate 2.2 - Transportation of Asphalt Concrete (source CHEC)*

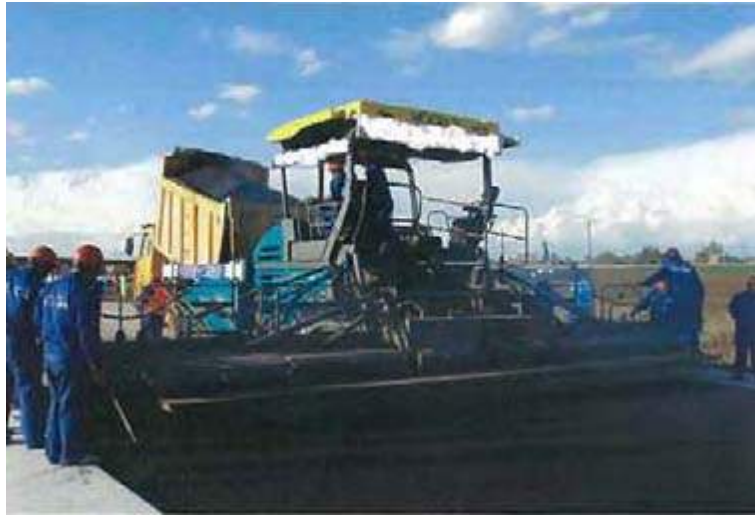
*Plate 2.3 -Asphalt Concrete Spreading (source CHEC)*

working condition to ensure the paving surface is even so as to reduce or to eliminate segregation. The elevation control method guided by steel wire shall be applied to spreading. The spreading speed will keep up with the step of material supply and compactors to ensure the consecutive and even spreading without interruption as much as possible (Plate 2.3).

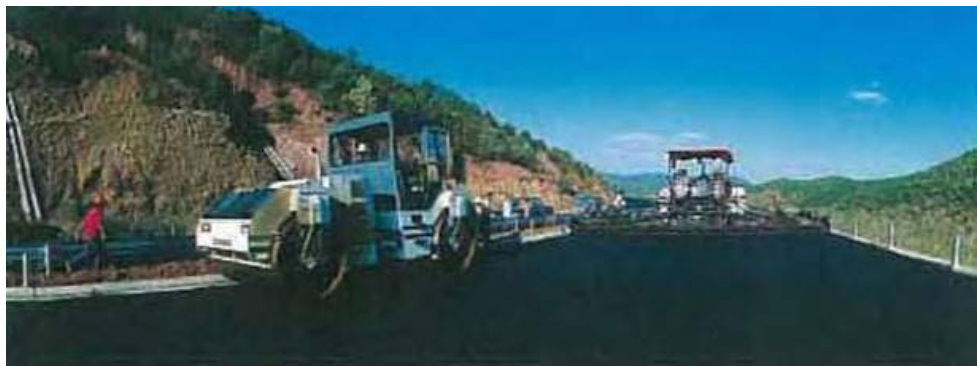
Asphalt concrete shall be immediately compacted after spreading. The concrete shall be compacted by 10t dual-drum vibration roller immediately after the paving (Plate 2.4).

*Plate 2.4 - Spreading and Compacting Asphalt Mixture (source CHEC)*

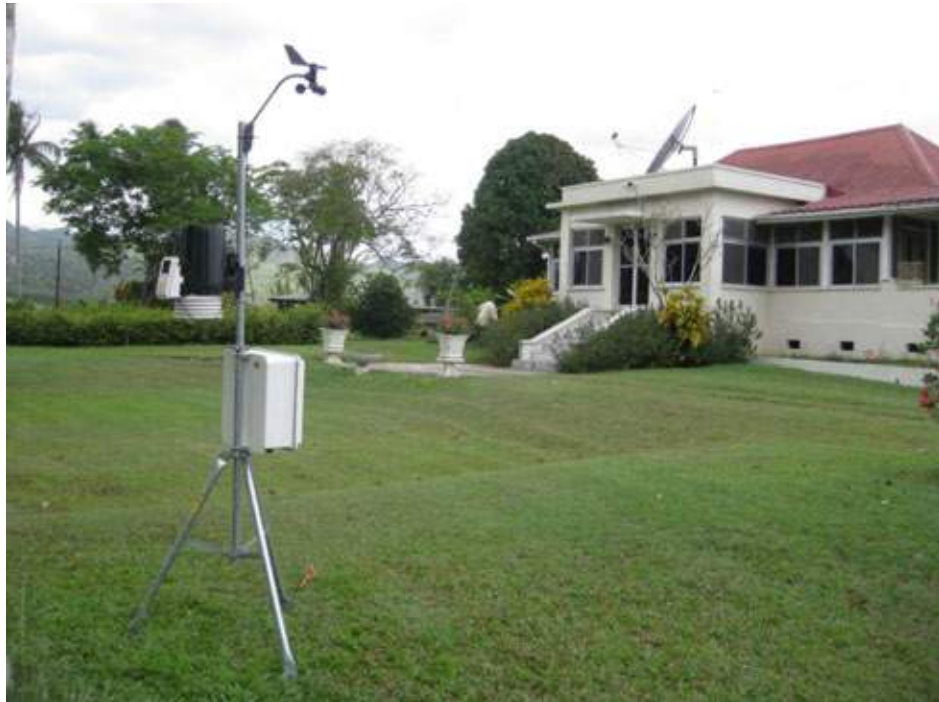
*Plate 4.1 - Photo showing weather station at N7 – Cambria Farms property*

Temperature, relative humidity, wind speed and direction, rainfall and barometric pressure were recorded at each of three (3) locations where noise monitoring was conducted (Stations N1, N4, and N7) over the seventy two (72) hours (Friday March 9<sup>th</sup> – Monday March 12<sup>th</sup>, 2012) by using a Davis Instruments wireless Vantage Pro2 weather system with a data logger and a complete system shelter erected on a tripod. Data were collected every ten minutes and stored on the data logger. This information was downloaded using the WeatherLink 5.9.2 software.

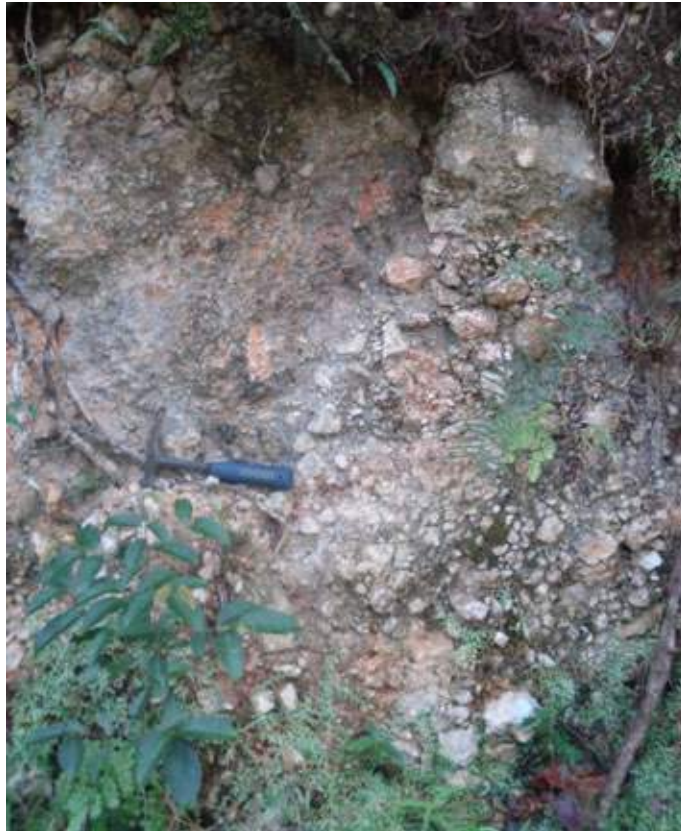
*Plate 4.2 - Outcrop view of the brecciated limestone that defines the fault zone south of Bog Walk. These are fracture bits of Newport and Troy/Claremont Limestones. Outcrops are fissile and are highly fractured and jointed*

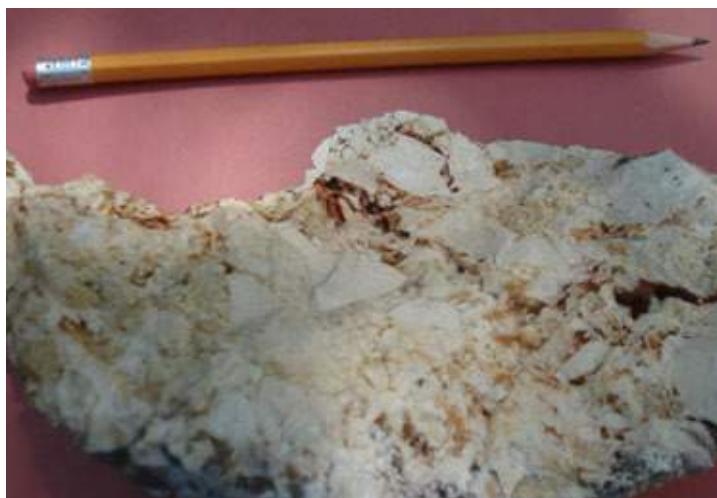
*Plate 4.3 - Hand specimen example of the brecciated limestone identified within the Bog Walk Fault zone*

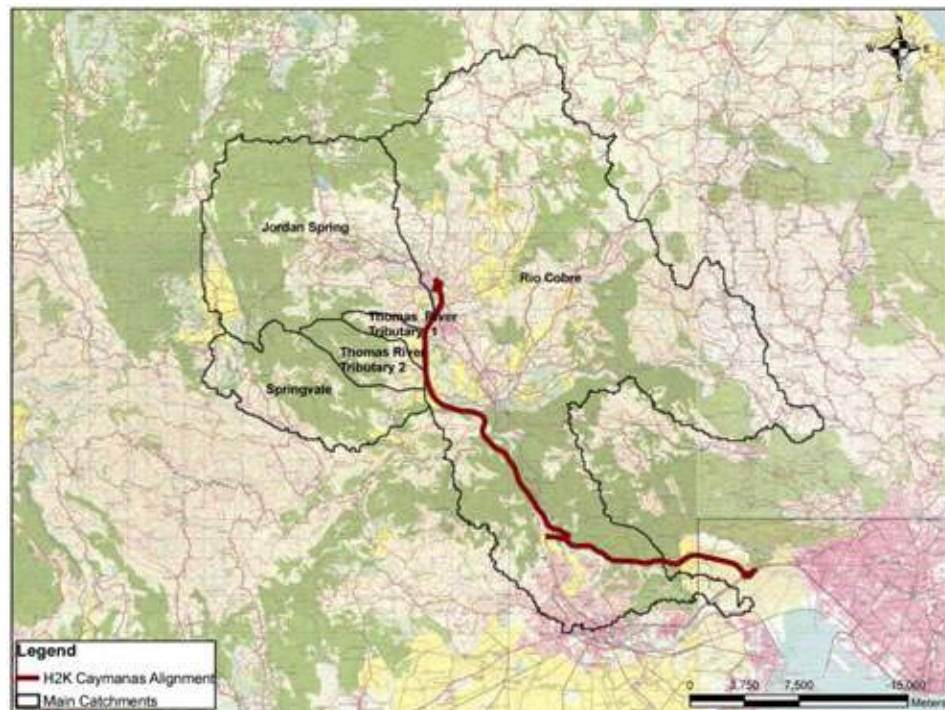
Figure 4-18 - Overall catchment area associated with H2K road alignment

It was found that the proposed alignment traverses a number of sub-catchments of a larger catchment area as illustrated in Figure 4-18. These catchments were delineated using a Digital Elevation Model (DEM) obtained from Digital Globe radar information. The overall total area of the sub-catchments that will impact the highway alignment is 465.9 km<sup>2</sup>, extending from Mannings Hill in the east to Thetford mountains in the west and Guys Hill in the north to Christian Pen in the south. The catchment is approximately 30.9 km long at its longest and 29.8 km wide.

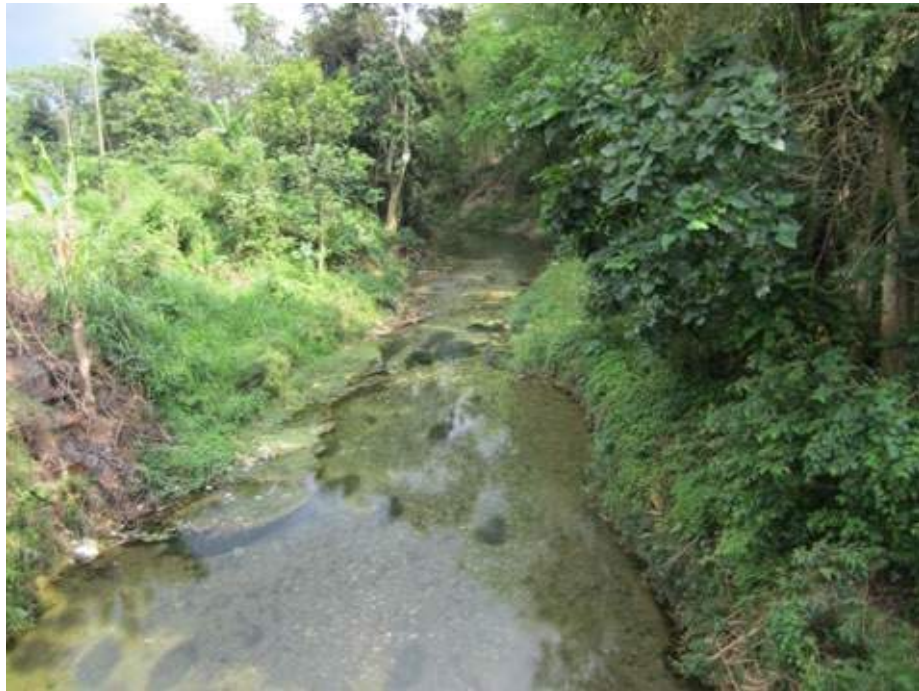
Jordan Spring starts in the north western area of Linstead, more specifically St. Thomas. It crosses the alignment in the vicinity of the Spanish Town Rd, Linstead which is a known flood prone area. Just north-west of the alignment, the Jordan Spring intersects and collects flow from the Byndloss Gully. Furthermore, south-east of the alignment the spring joins the Rio Magno Gully at the same location where Rio Cobre begins. The catchments associated with the spring crossing the alignment is approximately 8,767.20 hectares.

*Plate 4.4 - Jordan Spring upstream of H2K alignment crossing*

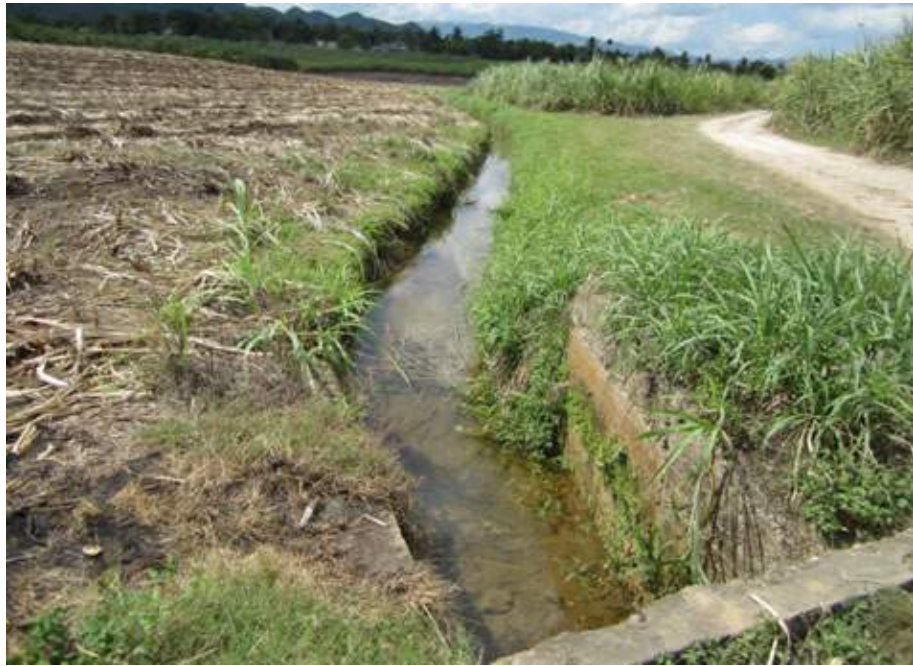
Main Stream (Thomas River Tributary 1) - The Thomas River crosses the alignment from west to east through a sugar cane plantation in the Wakefield vicinity. The total catchment area of this river is approximately 406.09 hectares. The catchment extends as far north as Guys Hill and is bounded on the east by Riversdale. This segment of the Thomas River which crosses the proposed alignment originates in the regions of Victoria, west of Linstead and continues in a south easterly direction until it discharges into the Rio Cobre.

*Plate 4.5 - Main stream of Thomas River where it intersects with proposed alignment*

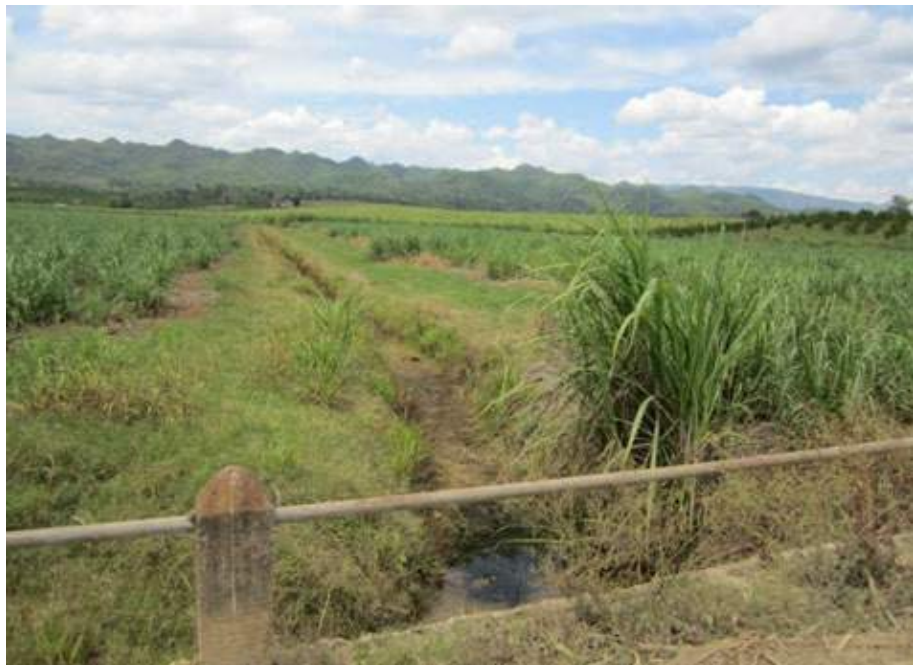
Tributary (Thomas River Tributary 2) - One tributary associated with the Thomas River crosses the Highway 2000 alignment in the Wakefield area, close to the Barry main road. This riverbed is often times dry in the absence of rain but quickly fills up during rainfall events in the upper catchment. The catchments associated with the Thomas River encompass an area of approximately 533.8 hectares. This segment of the Thomas River is one of two main tributaries which cross the proposed alignment.

*Plate 4.6 - A tributary of Thomas River where it intersects with proposed alignment*

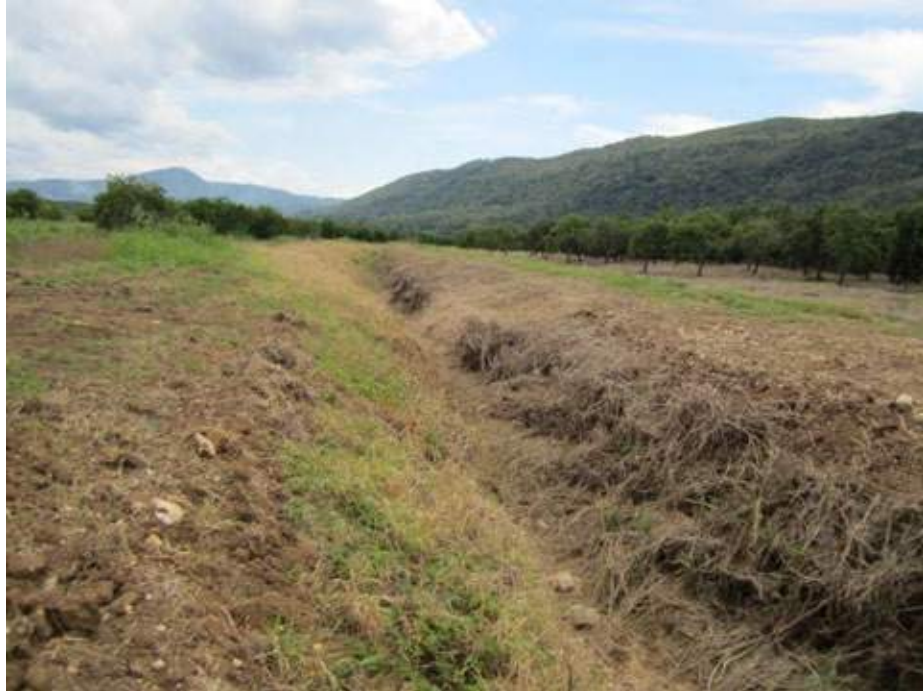
The Springvale River, a second tributary associated with Thomas River, originates north of Buxton Town and flows south-east. It intersects the Thomas River while flowing in a southerly direction east of the alignment in the general Wakefield area. The overall catchment area of the Springvale River before it crosses the alignment is approximately 4,006.64 hectares.

*Plate 4.7 - Dry riverbed of the Springvale River in absence of a rainfall event.*

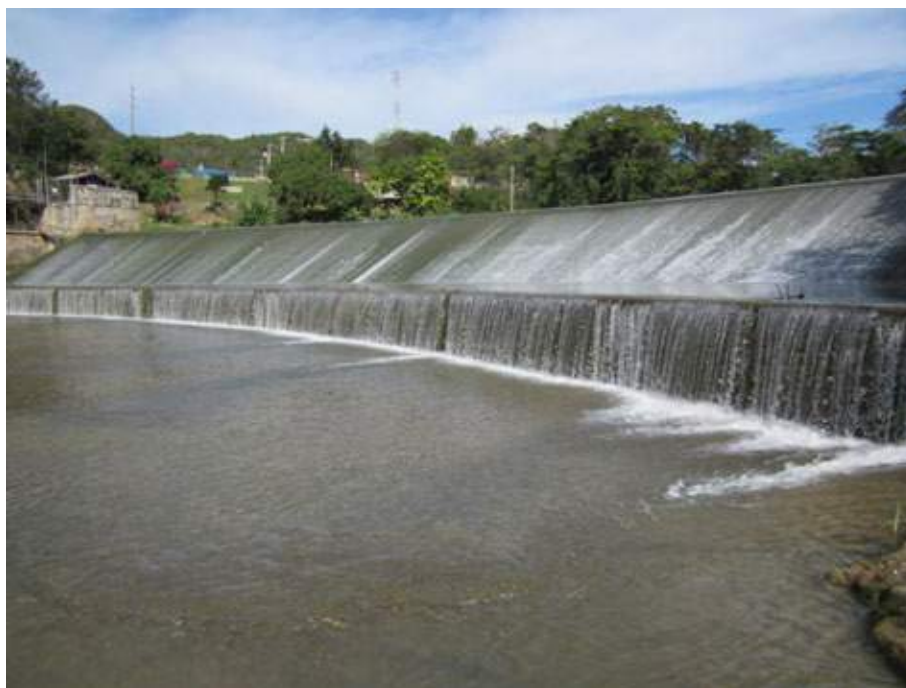
The Rio Cobre originates north of the alignment and flows south-east. It collects flows from the rivers aforementioned in the Bog Walk area and eventually discharges these flows into the sea. Having the largest area, the catchment associated with the Rio Cobre measures 46,140 hectares.

*Plate 4.8 - Rio Cobre Dam situated downstream of the proposed alignment crossing*

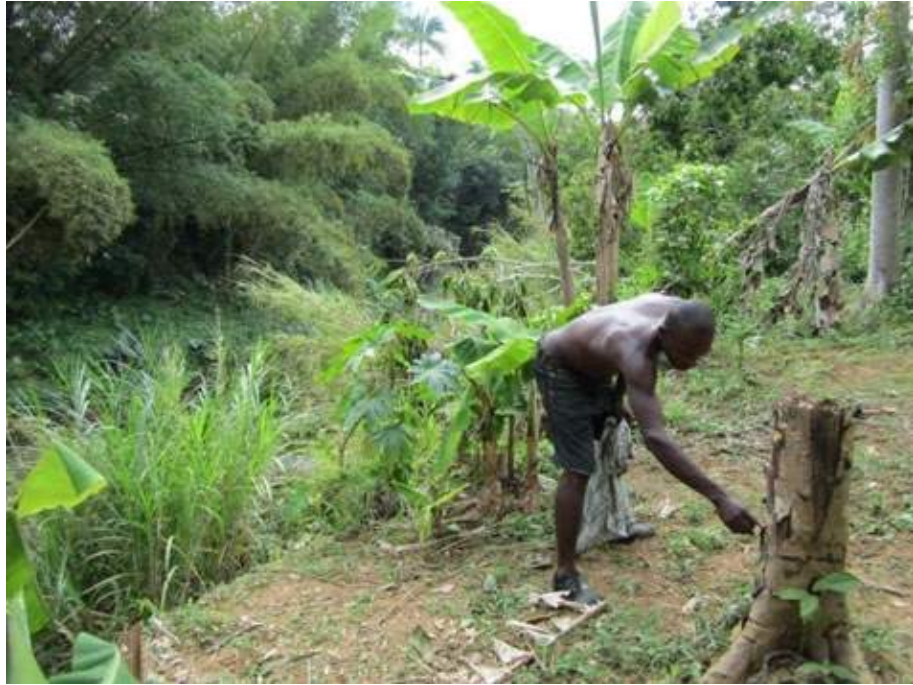
*Plate 4.9 - Farmer Glenmore Edwards identifies the flood levels caused by Jordan Spring during torrential rainfall almost 20ft above the river bed.*

| <i>River</i> | <i>ID</i> | <i>Name</i> | <i>Age<br/>(years)</i> | <i>Time<br/>lived in<br/>area<br/>(years)</i> | <i>Storm(s)</i> | <i>Year(s)</i> | <i>Flood<br/>depths<br/>(m)</i> | <i>Location</i> | <i>Debris Flow</i> | <i>Comments</i> |
|---|---|---|---|---|---|---|---|---|---|---|
| | 2b | Glenmore Edwards | 33 | 16 | October Rains | 2010 | 0.5 | Linstead | mud, brushes | Banana, Plantain crops destroyed (See Plate 4.9) |

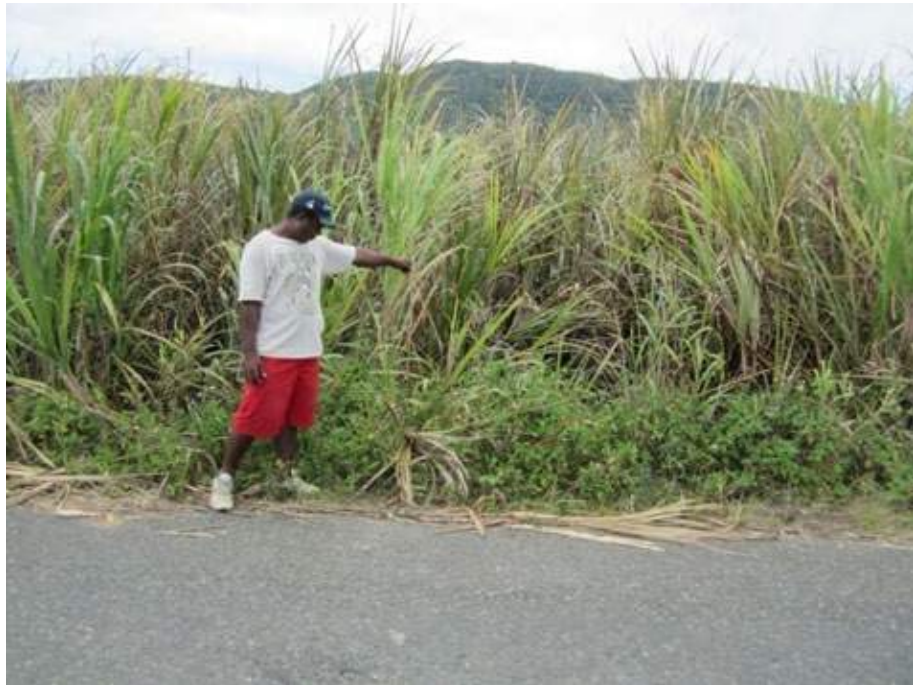
*Plate 4.10 - Resident Burru Cox illustrates the typical flood levels within the cane fields near Springvale River during heavy rainfall events.*

| <i>River</i> | <i>ID</i> | <i>Name</i> | <i>Age<br/>(years)</i> | <i>Time<br/>lived in<br/>area<br/>(years)</i> | <i>Storm(s)</i> | <i>Year(s)</i> | <i>Flood<br/>depths<br/>(m)</i> | <i>Location</i> | <i>Debris Flow</i> | <i>Comments</i> |
|---|---|---|---|---|---|---|---|---|---|---|
| <b>Springvale River</b> | 8 | Burru Cox | 28 | 17 | Dean<br>Gustav | 2007<br>2008 | 1.2 | Wakefield | mud, plastic bottles | Barry main road experience flooding (See Plate 4.10) |

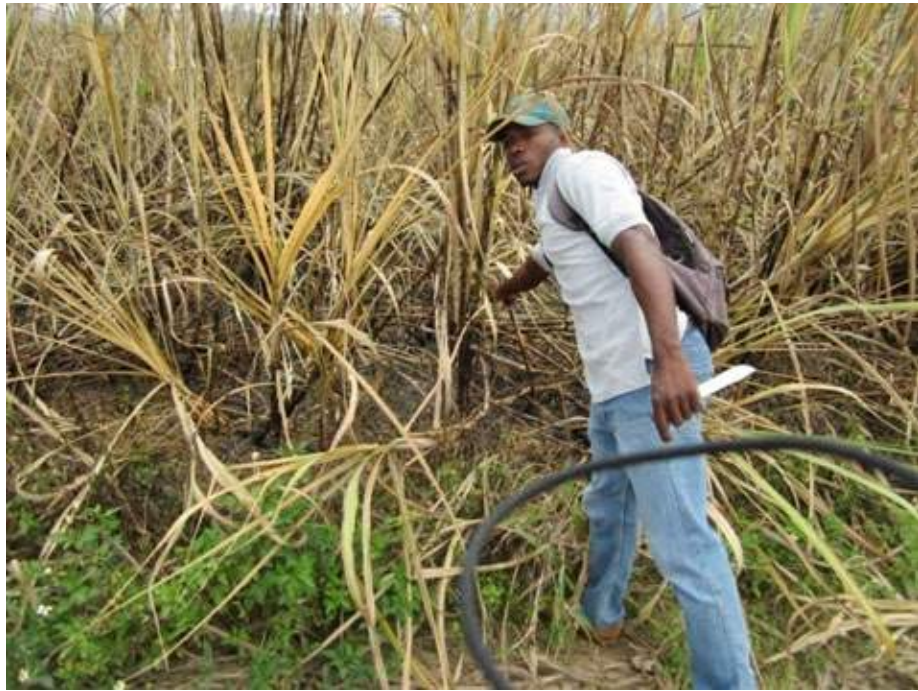
*Plate 4.11 - Resident Chevan Gordon identifies the flood levels produce by heavy rainfall events near Springvale River.*

| <i>River</i> | <i>ID</i> | <i>Name</i> | <i>Age<br/>(years)</i> | <i>Time<br/>lived in<br/>area<br/>(years)</i> | <i>Storm(s)</i> | <i>Year(s)</i> | <i>Flood<br/>depths<br/>(m)</i> | <i>Location</i> | <i>Debris Flow</i> | <i>Comments</i> |
|---|---|---|---|---|---|---|---|---|---|---|
| | | Gordon | | | Dean | 2007 | | | logs | (See Plate 4.11) |

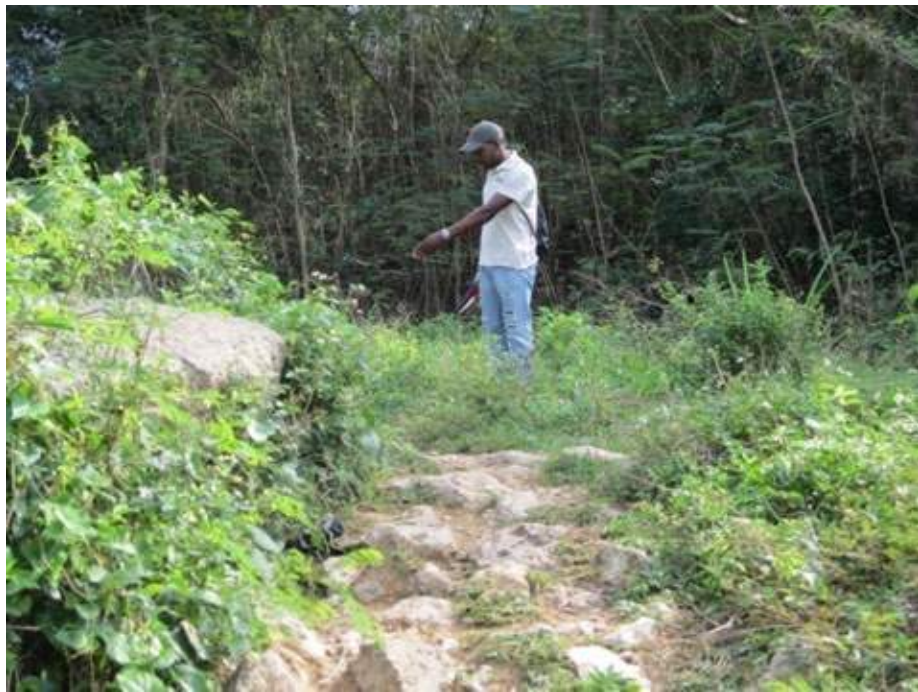
*Plate 4.12 - Resident Norval Cunningham illustrates that water levels generated during the June 2002 floods.*

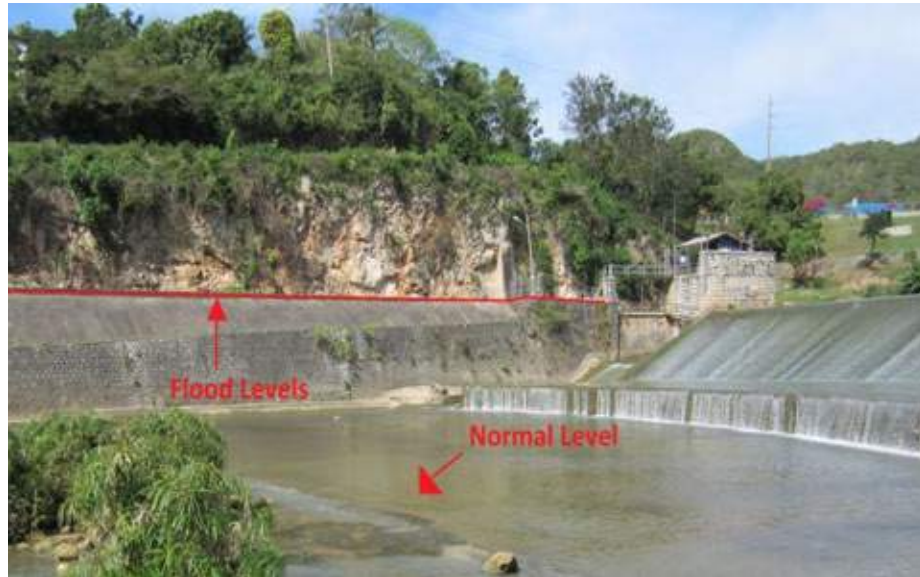
*Plate 4.13 - Flood levels of the Rio Cobre during the June 2002 floods.*

| <i>River</i> | <i>ID</i> | <i>Name</i> | <i>Age<br/>(years)</i> | <i>Time<br/>lived in<br/>area<br/>(years)</i> | <i>Storm(s)</i> | <i>Year(s)</i> | <i>Flood<br/>depths<br/>(m)</i> | <i>Location</i> | <i>Debris Flow</i> | <i>Comments</i> |
|---|---|---|---|---|---|---|---|---|---|---|
| | 12b | Winston<br>Curtis | 39 | 36 | June<br>Floods | 2002 | 1.5 | Rio Cobre<br>Dam | trees, plastic<br>bottles | Dam destroyed; Water levels<br>reach height of dam wall and<br>overflows into canal<br>(See Plate 4.13) |

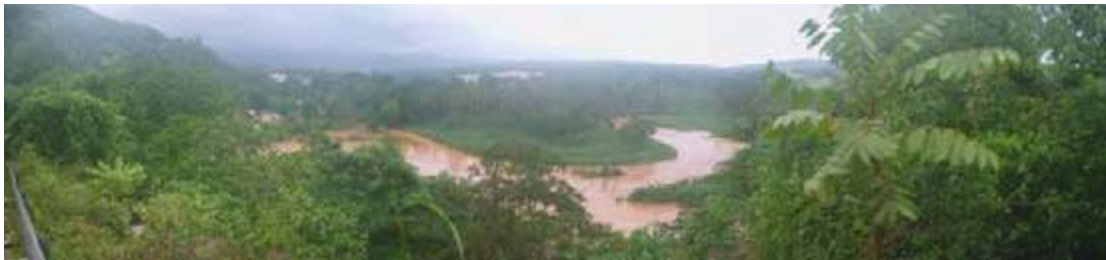
A 2007 study<sup>2</sup> conducted for NROCC highlighted several flood prone areas extending from of Bog Walk to the northern termination point. It was reported that flooding was due mainly to ponding and overflowing of the Rio Cobre. See Plate 4.14 which shows the Rio Cobre in spate in a 2008 photo and Plate 4.15 which shows the Jordan Spring north of the proposed alignment.

*Plate 4.14 - 2008 Photo of the Rio Cobre in spate east of the existing road alignment in Bog Walk*

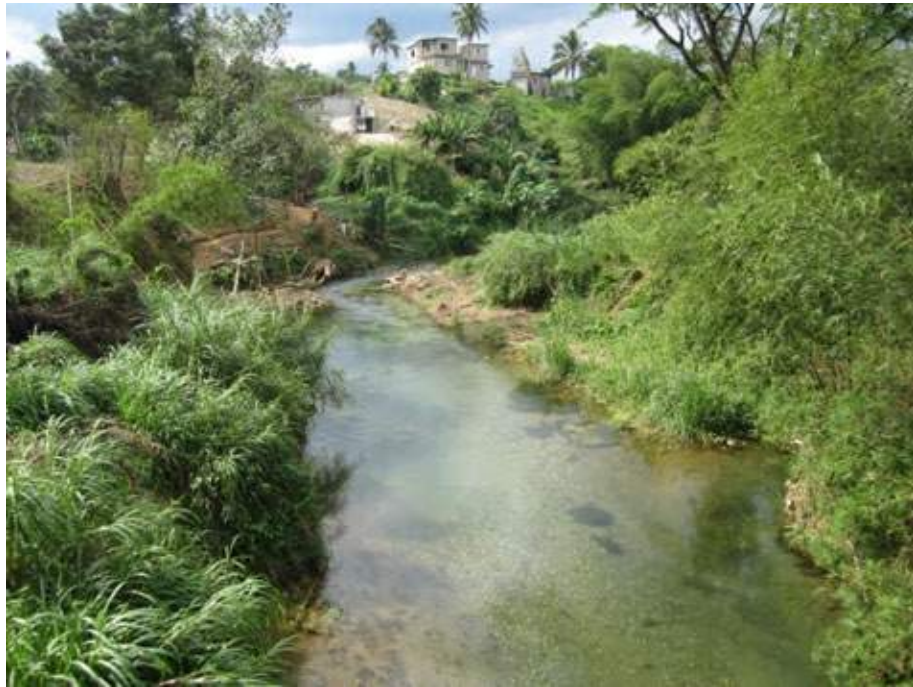
*Plate 4.15 - 2012 Photo taken of the Jordan Spring north of the proposed highway alignment in Linstead*

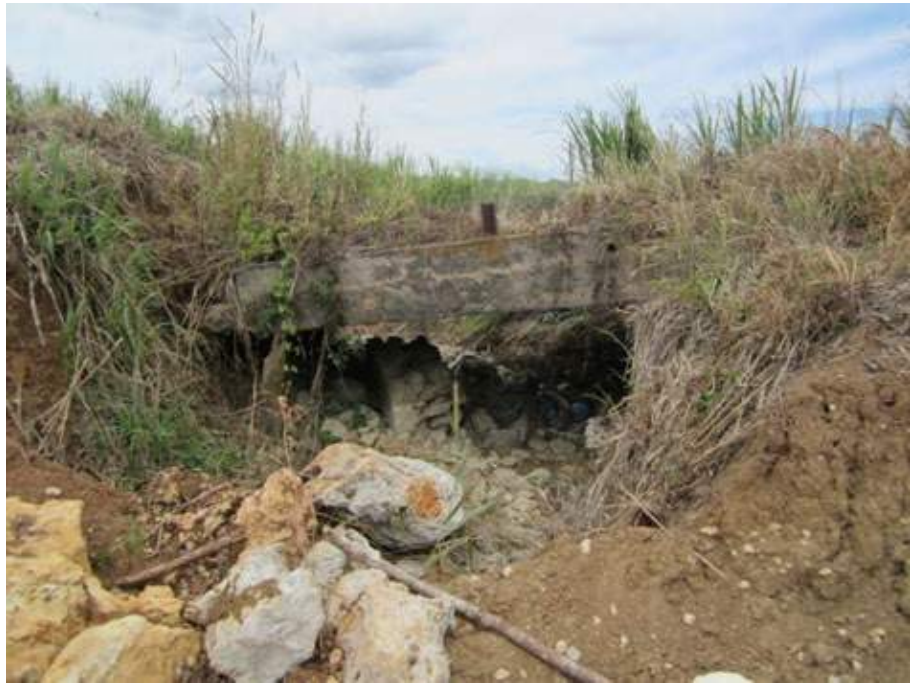
More importantly, flooding can be influenced by blocked drains which limit the transmission of floodwaters through the channel and across the existing road embankments. Plate 4.16 identifies the blockage of a segment of the Springvale River located under an abandoned bridge. This prohibits the free flow of the river which consequently overflows its banks and floods the surrounding fields and settlements.

*Plate 4.16 - A section of the Springvale river blocked by rubble.*

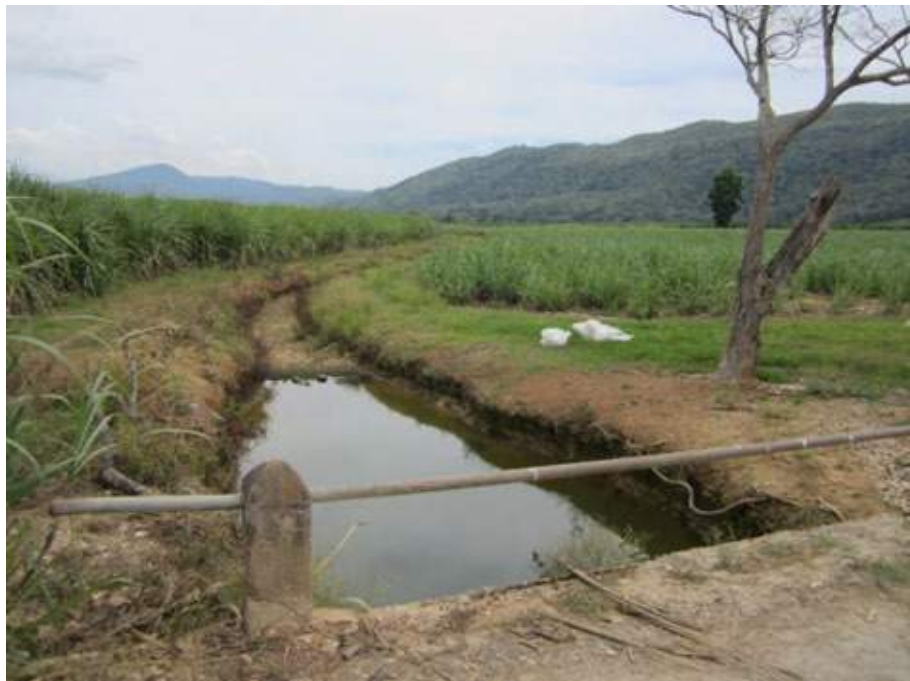
The low-lying areas within which the citrus and cane fields are situated also contribute to the events of floods in the area (Plate 4.17). These regions are prone to flooding as they create a ponding effect, similar to wetlands.

*Plate 4.17 - Thomas River flowing through low lying cane fields in Wakefield*

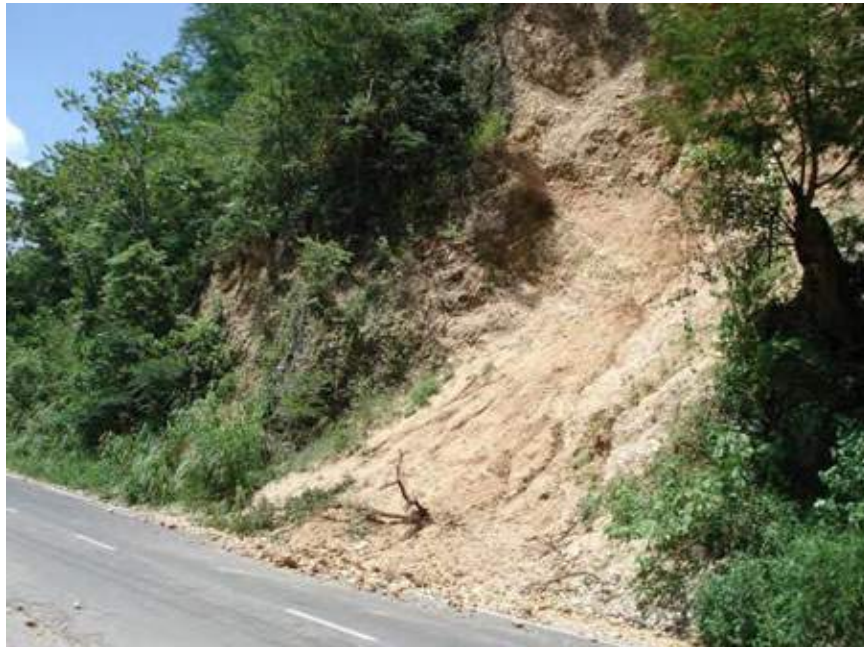
*Plate 4.18 - Land slip on the southern edge of the fault zone exposed along the main road at the northern entrance to the Bog Walk Gorge (Walderston formation). This location is within the same Bog Walk Fault zone as will be traversed by the proposed highway.*

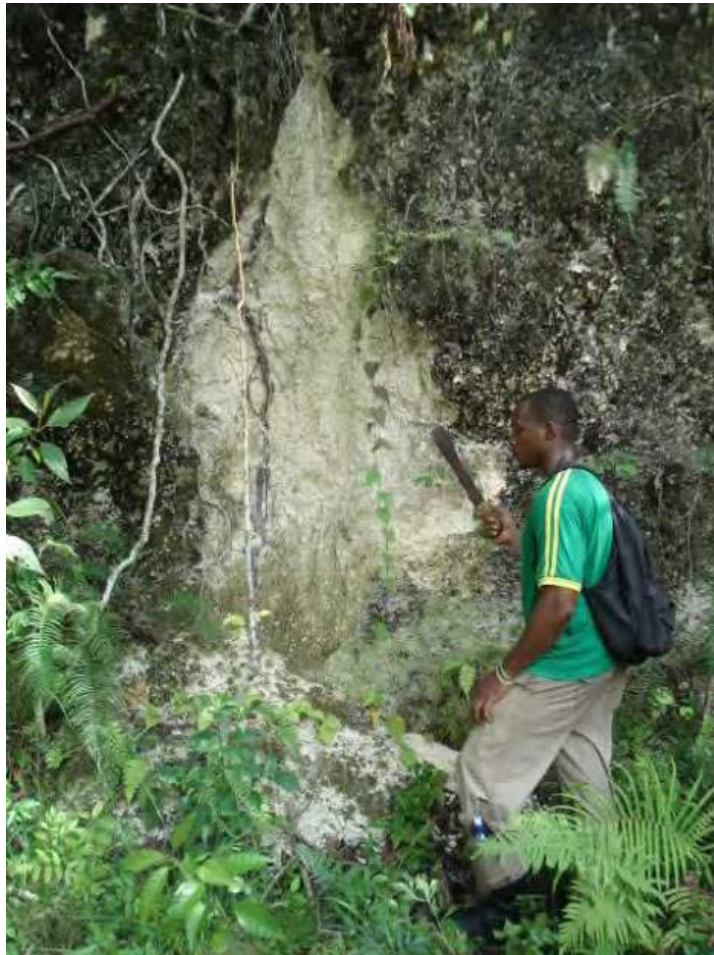
*Plate 4.19 - Soft (can be penetrated with cutlass in photo) brecciated material prone to land slips in fault zone (Undifferentiated Troy/Claremont and Somerset formations)*

The Bog Walk Fault zone consists of a broad belt of mainly limestones that have been extensively brecciated (Plate 4.2). The brecciation will result in potentially unstable slopes being exposed during and after construction of the highway, so the potential for landslides is high. If the highway route also intersects slivers of volcanoclastic rocks (Cretaceous units), presently just west of the proposed route in the Giblatore area (Figure 4-11) this potential will become even higher. Active landslides have been encountered along, or in the vicinity of, the proposed highway route (Plate 4.18 and Plate 4.19). Of particular note are the fissile brecciated units associated with the fault zone in which they occur as these are found along the proposed highway route (Plate 4.19).

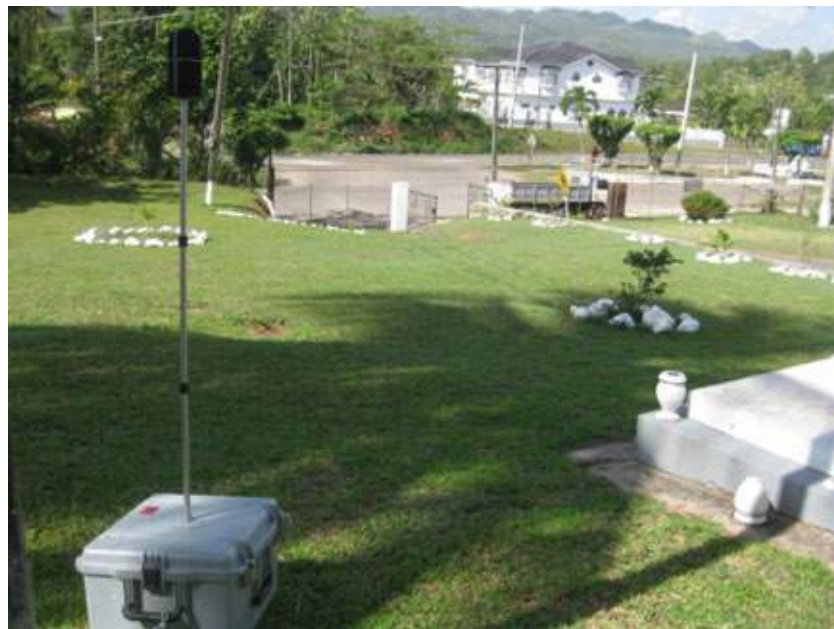
Plate 4.30 - Photo showing noise meter at Station N9 - Vanity Fair, Linstead

A windscreen (sponge) was placed over the microphone to prevent measurement errors due to noise caused by wind blowing across the microphone. Plate 4.30, Plate 4.31 and Plate 4.32 shows noise monitoring outdoor kits at three locations.

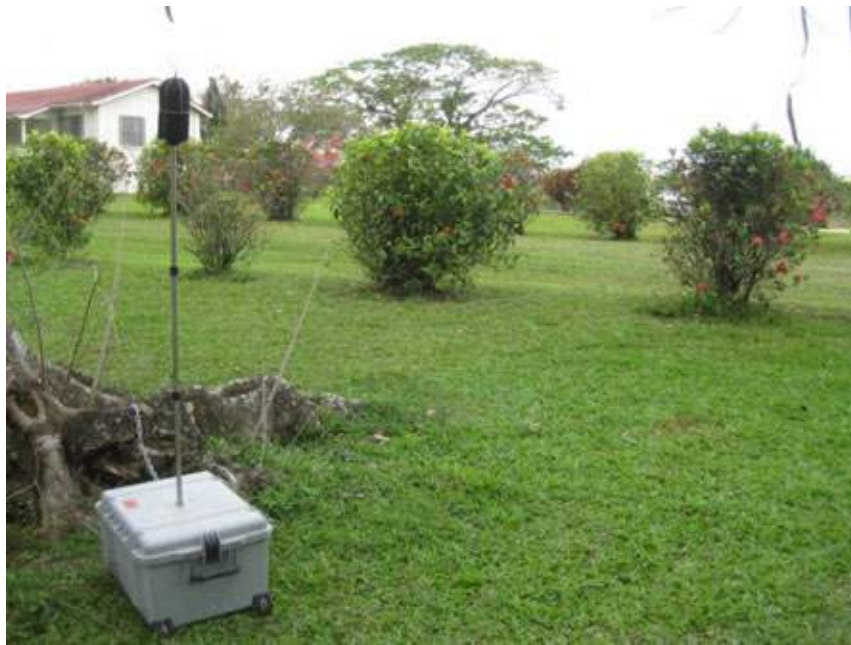
*Plate 4.31 - Photo showing noise meter at Station N7 - Cambria Farms*

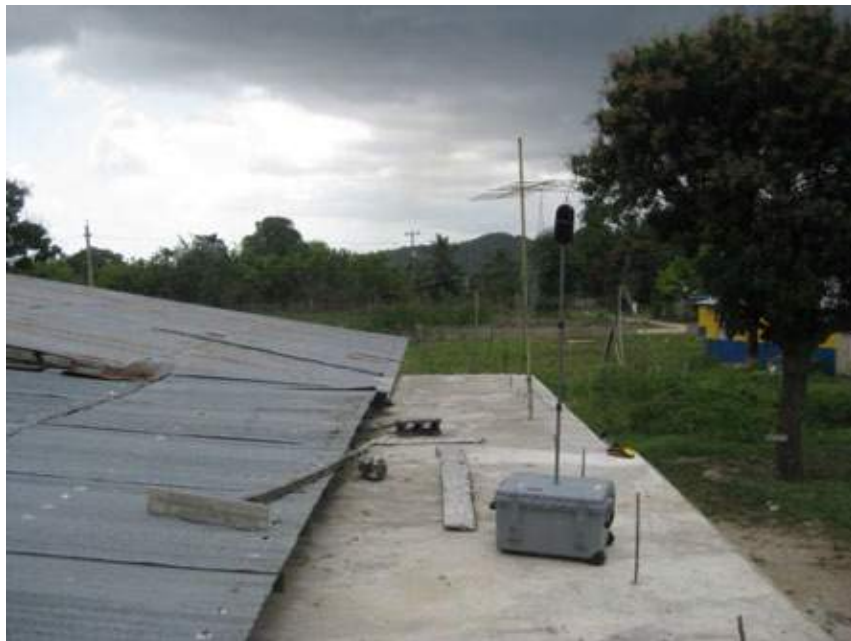
*Plate 4.32 - Photo showing noise meter at Station N4 - Content*

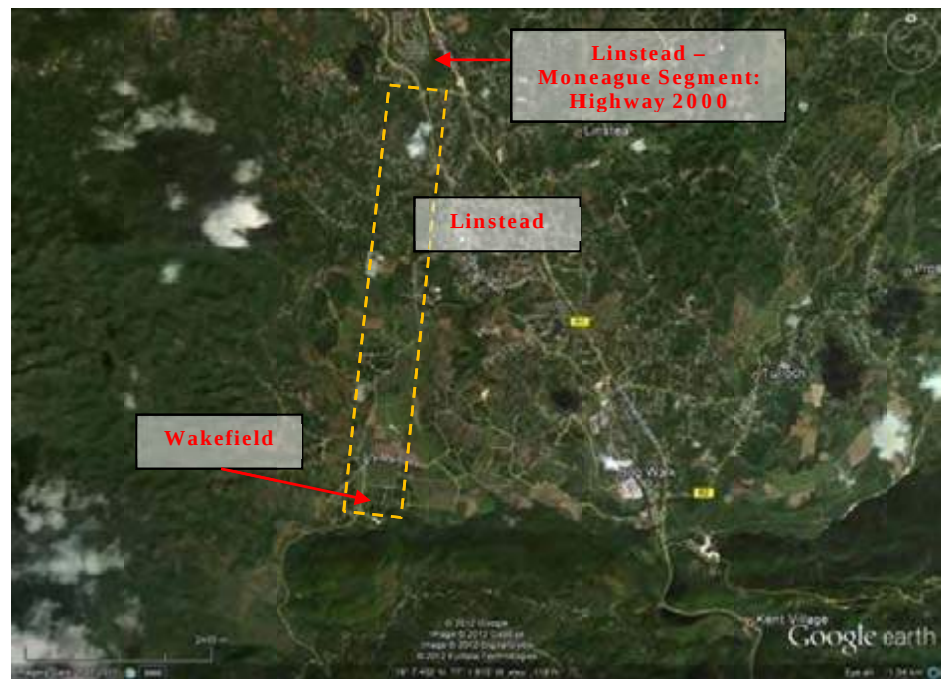
*Figure 4-89 - Satellite image of the NW lowland regions of the planned highway development. Highlighted area shows the general & adjacent that may be affected by the rights-of-way*

There were two main lowland areas: one located southerly, to the east of Central Village (Figure 4-88) and the other, adjacent to the large town of Linstead in the north (Figure 4-89). The vegetation in these areas showed severe anthropogenic influence, evidenced by large-scale orange and sugar cane cultivation, as well as several hectares of pastureland. Some isolated dwellings and settlements were also encountered, especially within the northern lowland areas thus influencing the characteristics of the nearby flora with the persistence of garden ornamentals and fruit trees.

Window surveys were conducted for the modified lands, typically occurring on the plains toward the NW and SE sections of the study area (Figure 4-88, Figure 4-89 and Figure 4-90) and the degraded woodlands, found on the shallow slopes of the eastern elevations (Figure 4-91). In these locales, the existing road network was utilised to traverse the communities to be affected by the proposed development. Stops (locations A-J) were made at regular intervals to conduct walk-throughs for more thorough investigations. This process was aided by a Trimble GeoExplorer™ 6000 Series GeoXT™ handheld GPS unit programmed with the coordinates of the highway path. Notes were made regarding the phanerophytic and herbaceous plant species encountered and the land-use types observed.

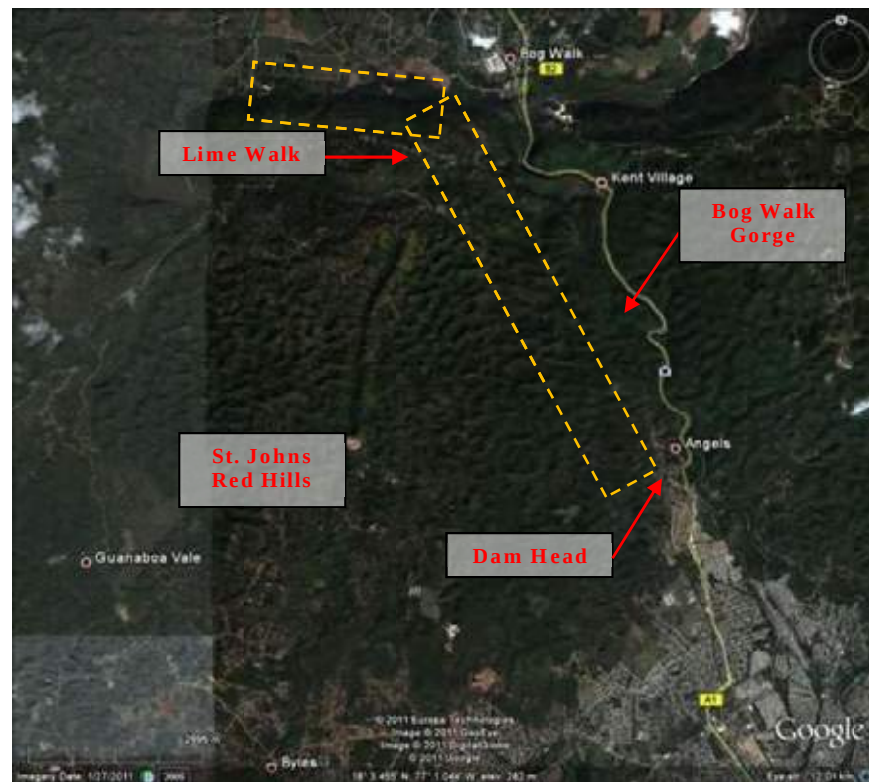
In general, the highland areas appeared significantly less disturbed than the lowland areas. Nonetheless, man's influence on the environment could be seen with the occurrence of a few village-settlements and isolated dwellings. These were usually associated with subsistence agriculture of several fruit trees (such as Ackee, Breadfruit, Star-apple and Allspice), including some pastureland. There were two main "highland" areas to be impacted by the highway development, namely those areas between Caymanas Bay and Content (easterly) and between Dam Head and near Lime Hill (westerly) (Figure 4-90).

Figure 4-90 - Satellite image of the western highland regions of the planned highway development (a section of St. Johns Red Hills). Highlighted area shows the general & adjacent lands that may be affected by the rights-of-way

Additionally, there were established and informal road networks that varied in class and maintenance. These ranged from relatively well maintained arterial roads to avenues and lanes in developed human communities (Figure 4-90).

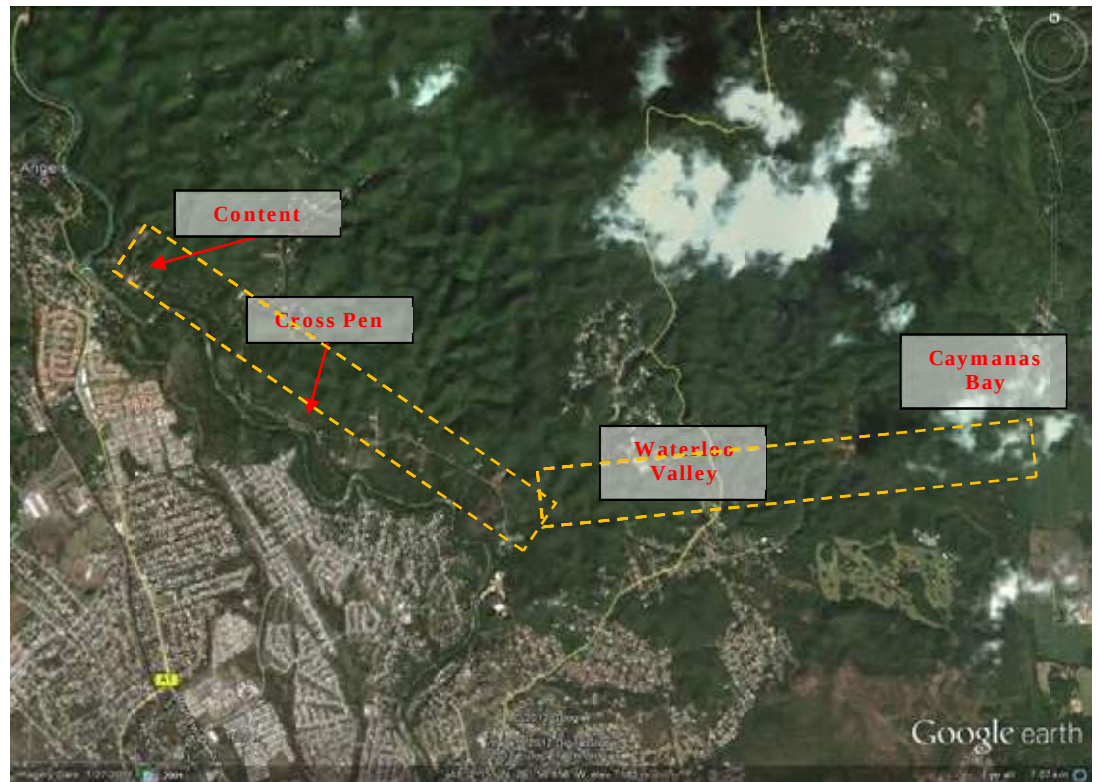
The elevations of the easterly rights-of-way (Figure 4-91) differed somewhat in topography and vegetation type. The terrain appeared less steep than the western highland areas, consisting mainly of approximately 20 – 30 degree gradients. The vegetation also appeared indicative of increased levels of disturbance and reduced rainfall. According to the Caribbean Vegetation Mapping Initiative (2000), the area is occupied by a mixture of lowland semi-deciduous and disturbed lowland/submontane semi-deciduous forests. Road penetration and class were also improved and coupled with gentler slopes, seemed to have allowed for easier access to anthropogenic influence.

*Figure 4-91 - Satellite image of the eastern highland regions of the planned highway development. Highlighted area shows the general & adjacent lands that may be affected by the rights-of-way*

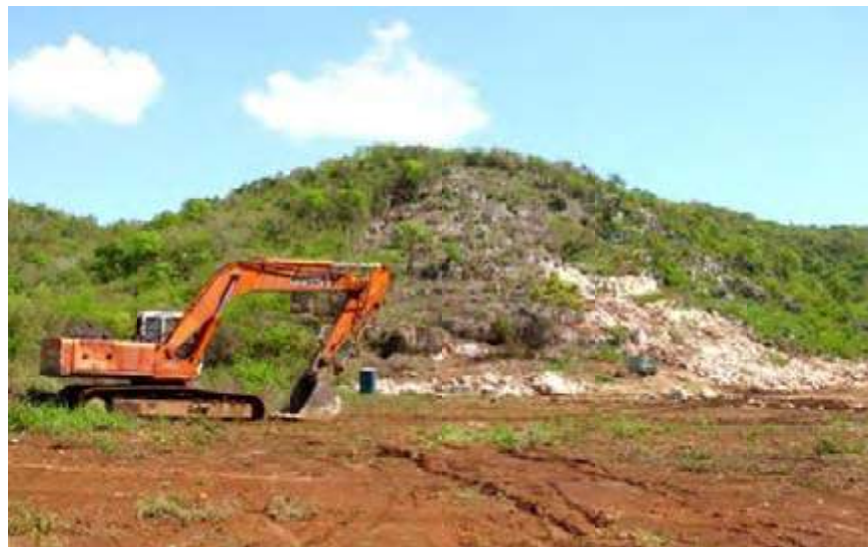
*Plate 4.34 - Quarry activity located within the eastern highlands near Cross Pen*
