# ENVIRONMENTAL IMPACT ASSESSMENT

Proposed Highway 2000 North South Link -  
Caymanas to Linstead

*Date:*                      **August 2012**

*Prepared by:*          **CL ENVIRONMENTAL CO. LTD.**

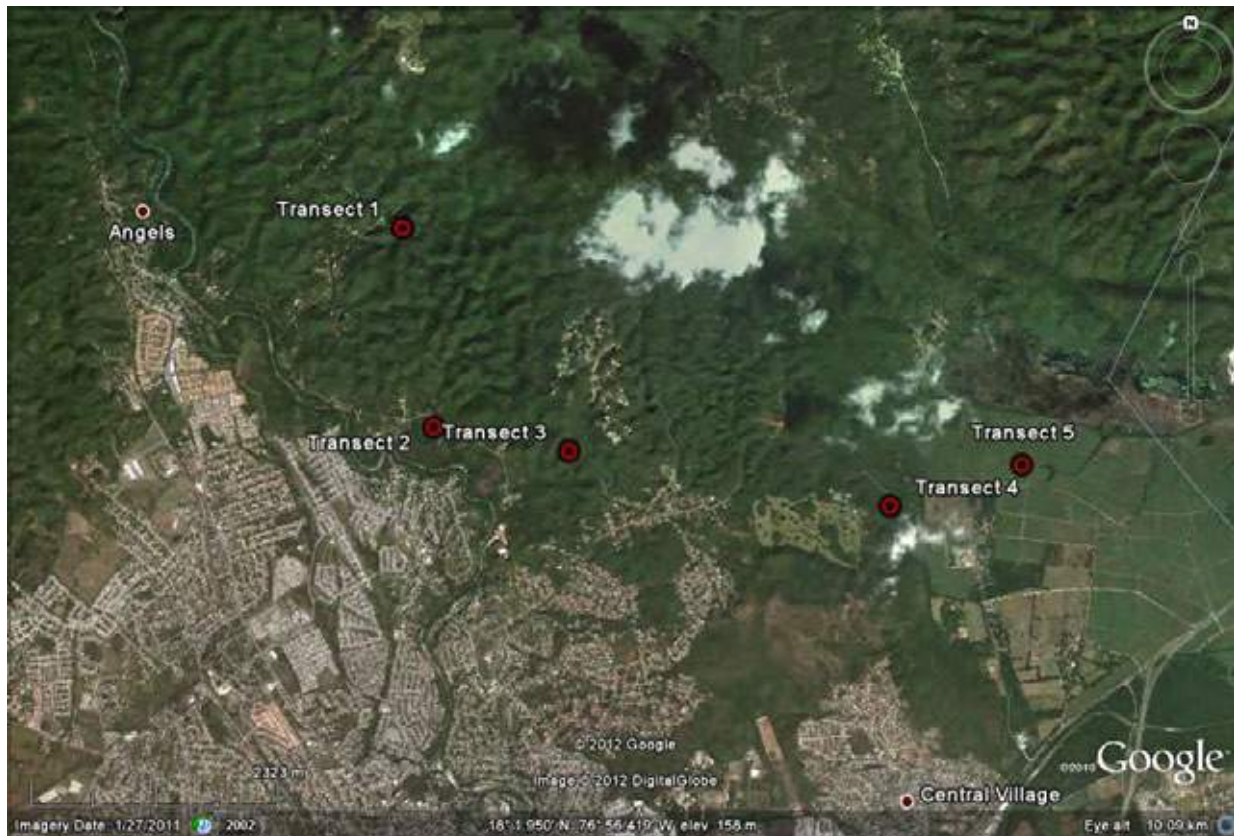
### 9.2.4 Emergency Response

The area is dominated by dry limestone forest. Additionally there were sections which may be described as Gully Forests; as the name suggests these occurred in narrow, sometimes deep valleys, where the moisture level was distinctly higher than the open areas. The forest in the area has been the subject of significant amount of human activity and there were significant cane plantations. The study sites that were established (Figure 4-100) ensured representation of the major habitat types.

- 1) Gully forest
  - a. Transect 1
- 2) Dry limestone forest
  - a. Transect 2 – secondary forest
  - b. Transect 3 (below St Jago Heights) – disturbed forest
  - c. Transect 4 (Caymanas Hills) – disturbed forest
- 3) Canefields
  - a. Transect 5 - Caymanas

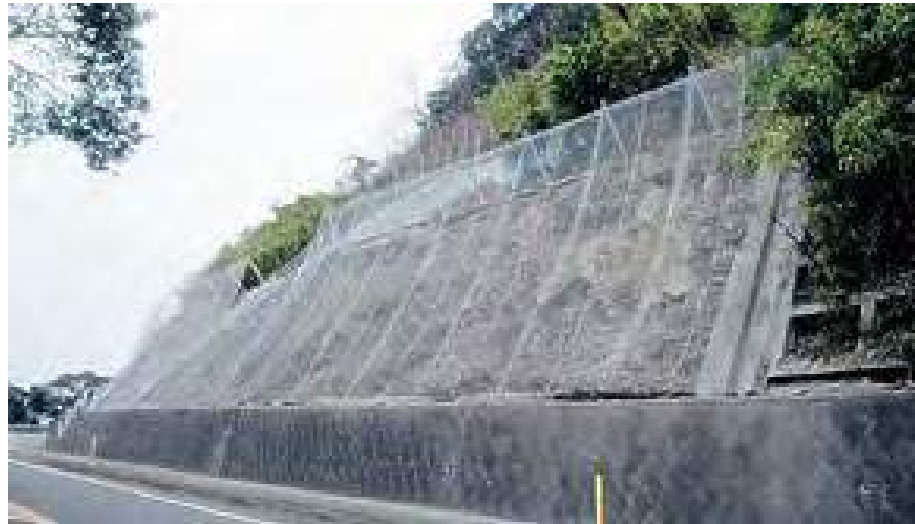
*Plate 9.1 - Rockfall catchment fences being implemented*

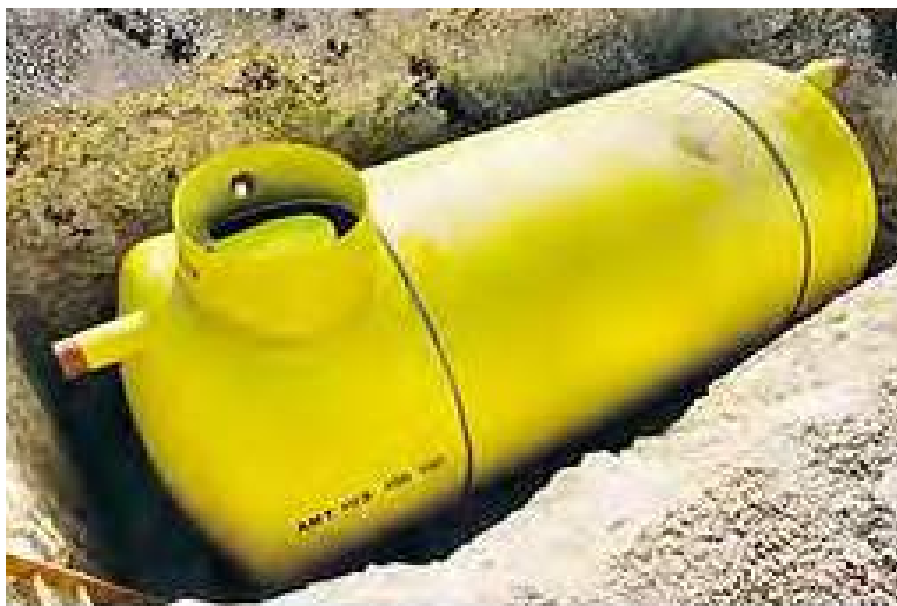
*Plate 9.2 - Filling station forecourt separator*

- v. The developers should consider installing a combination of wetland detention basins, oil separators or interceptor within the drainage system which will facilitate the filtering of the local water system from toxic contaminants. An example of an oil separator is shown below:

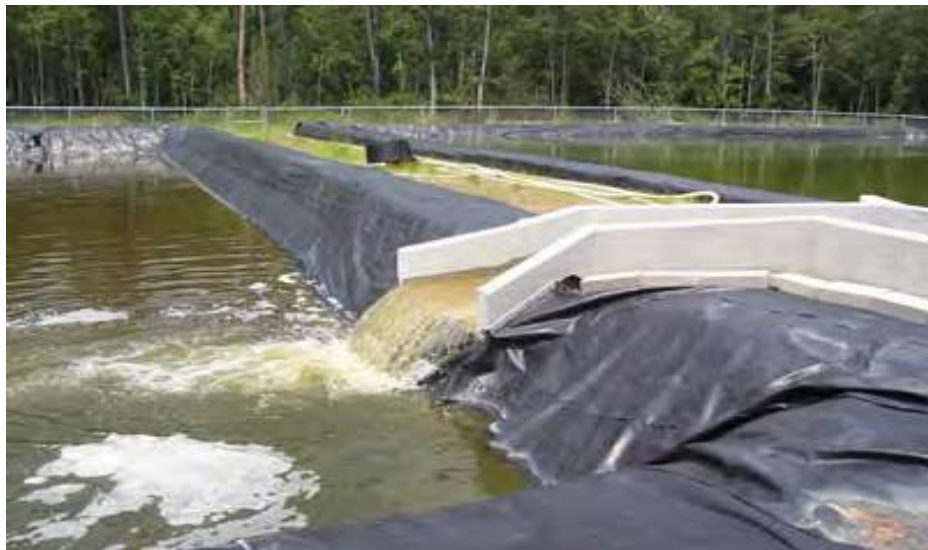
*Plate 9.3 - Detention ponds used to reduce peak flows*

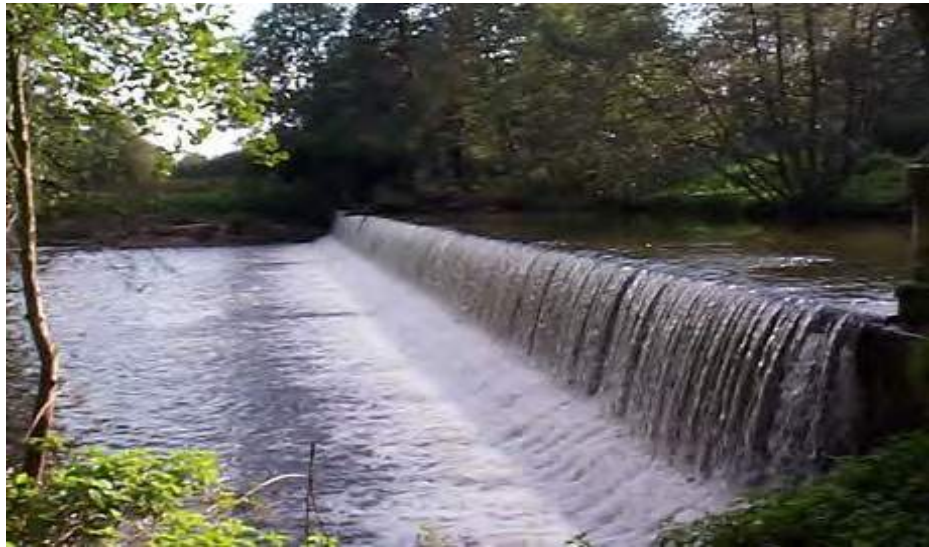
*Plate 9.4 - Example of weir which may be used in conjunction with a detention pond*

- iii. In light of no hydraulic report being submitted a detailed hydraulic report that meets and exceeds the requirements of the National Works Agency should be prepared and submitted for review by the Engineers.
- iv. Consider the use of use detention ponds or retarding basins which aid in the reduction of the peak flows in the drains crossing the highway (Plate 9.3). In addition, a weir may be constructed to further alter the flow characteristics (Plate 9.4).

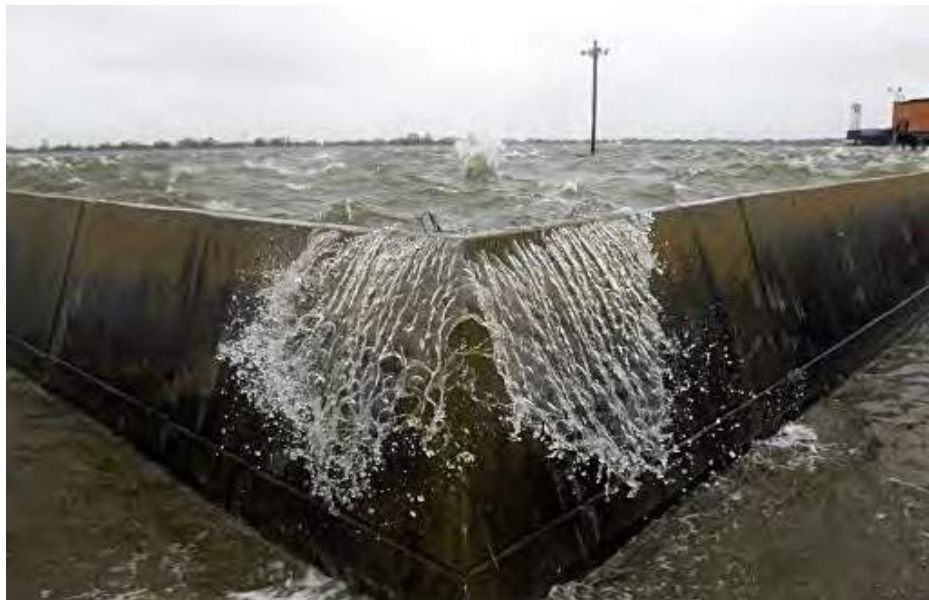
*Plate 9.5 - Levee implemented in New Orleans during storm Gustav*

- v. Levees are implemented to impede the collection of water. Levees are embankments composed of soil and earthen material such as sandbags that are used to prevent flooding controlling the rate of runoff.

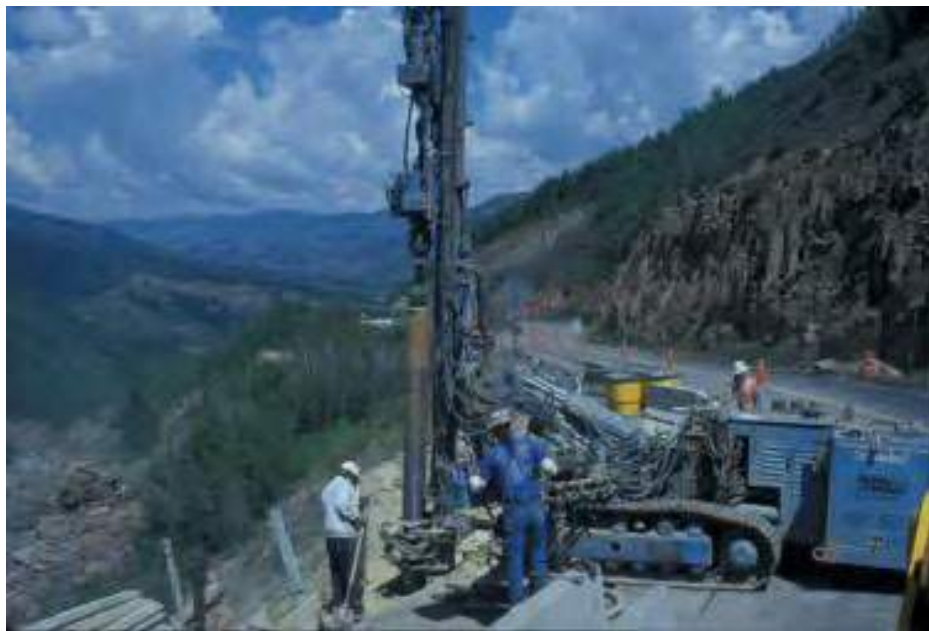
*Plate 9.6 - Installation of metal soil nails at edge of slope*

- i. The introduction of reinforcement elements such as metal soil nails (Plate 9.6) or anchors to increase the shear strength of the rock and to reduce the stress release created subsequent to soil cutting. Gravity walls or concrete walls with counterforts may also be introduced.

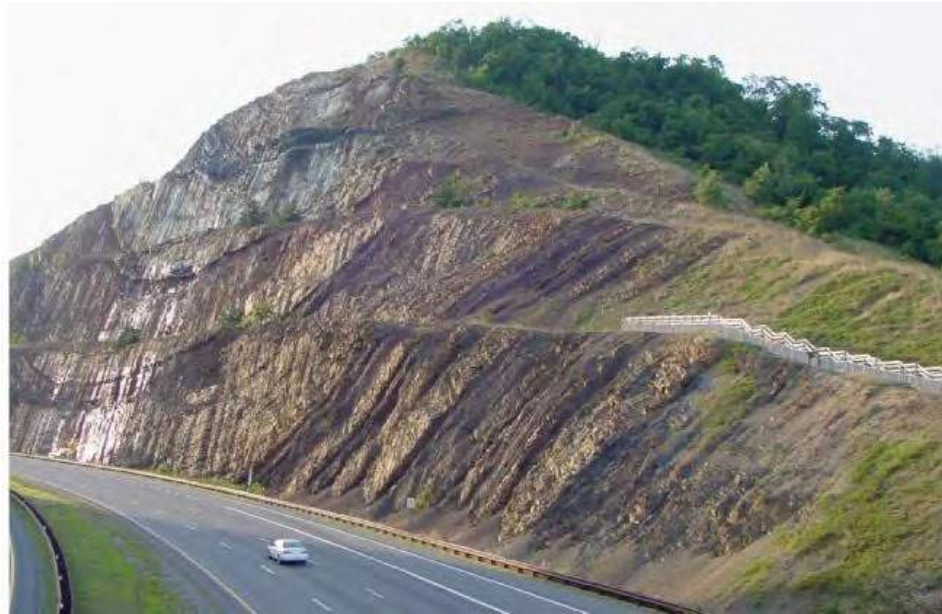
*Plate 9.7 - Bench trail cut on face of steep slope*

- ii. Re-profiling the slope with the purpose of improving stability by either reducing the slope angle or cutting benches into the

face of the soil. There are three options: Balanced cut and fill, full bench cut or through cut.

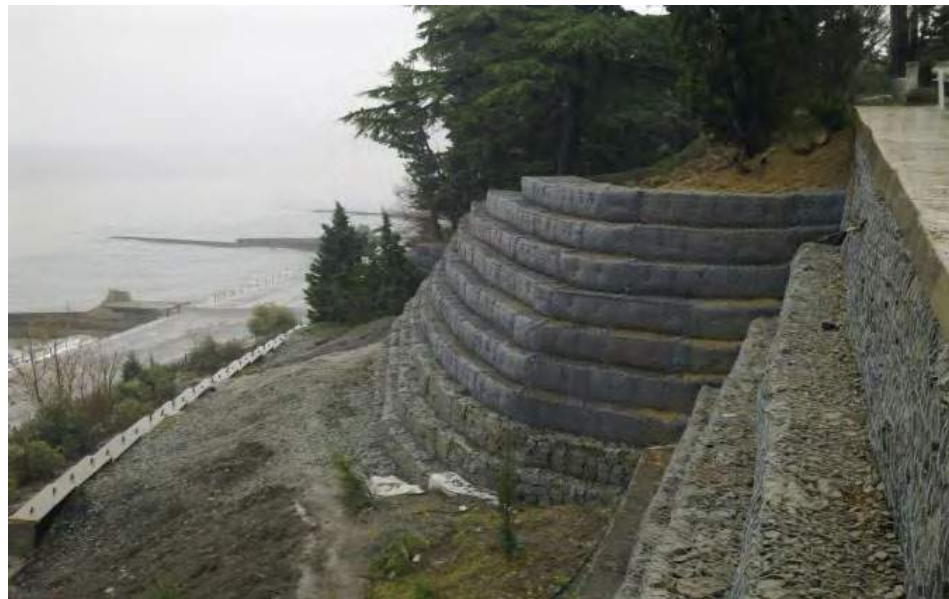
*Plate 9.8 Gabion walls erected along face of steep slope*

- iii. Erecting gabion walls from the foot of the slope along its faces which act as a type of low gravity retaining structure. These are generally wire frames filled with aggregates as seen below:

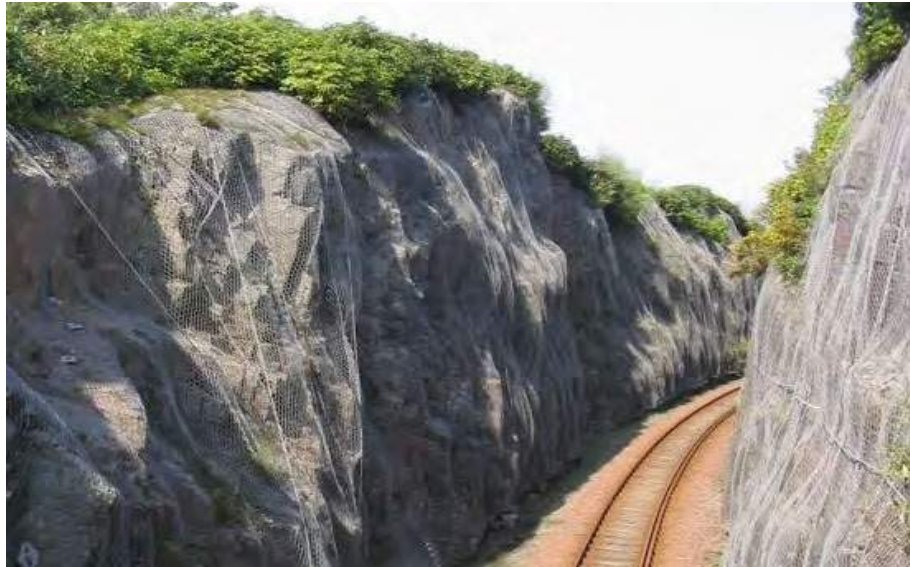
*Plate 9.9 - Rockfall netting used to protect trains from falling rocks*

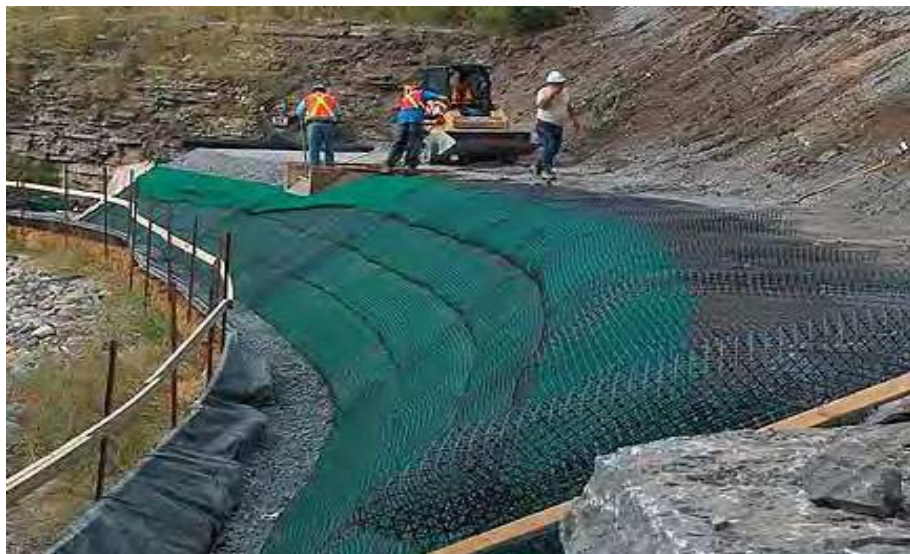
*Plate 9.10 - Geogrids being placed on face of slope*

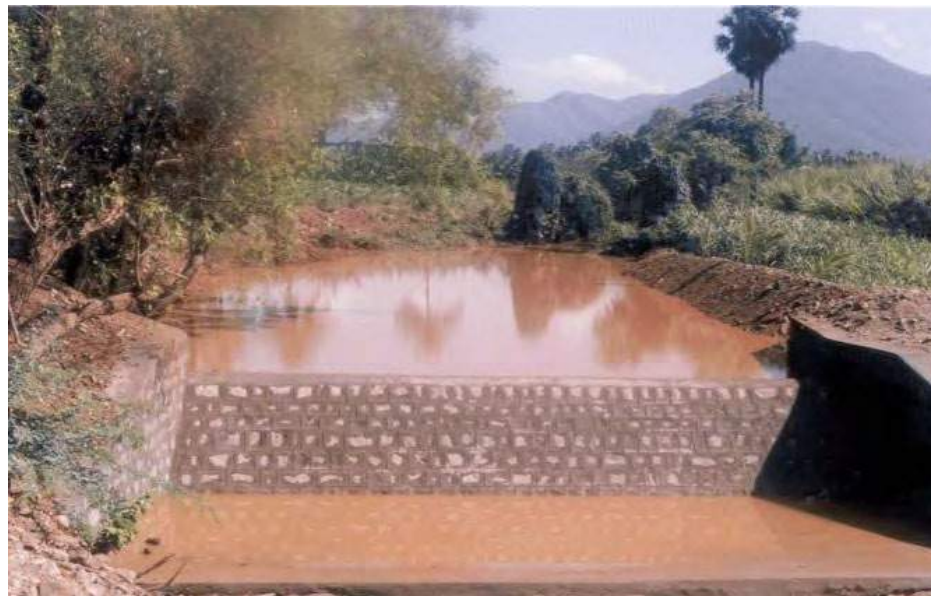
*Plate 9.11 - An example of a check dam being used*
